Facility: Thomas Hayward Agriculture & Nutrition

Subject: Area in front of the facility (on the south side of the property) looking west with the Harcros facility in the background.

RCRA 6/27/1995

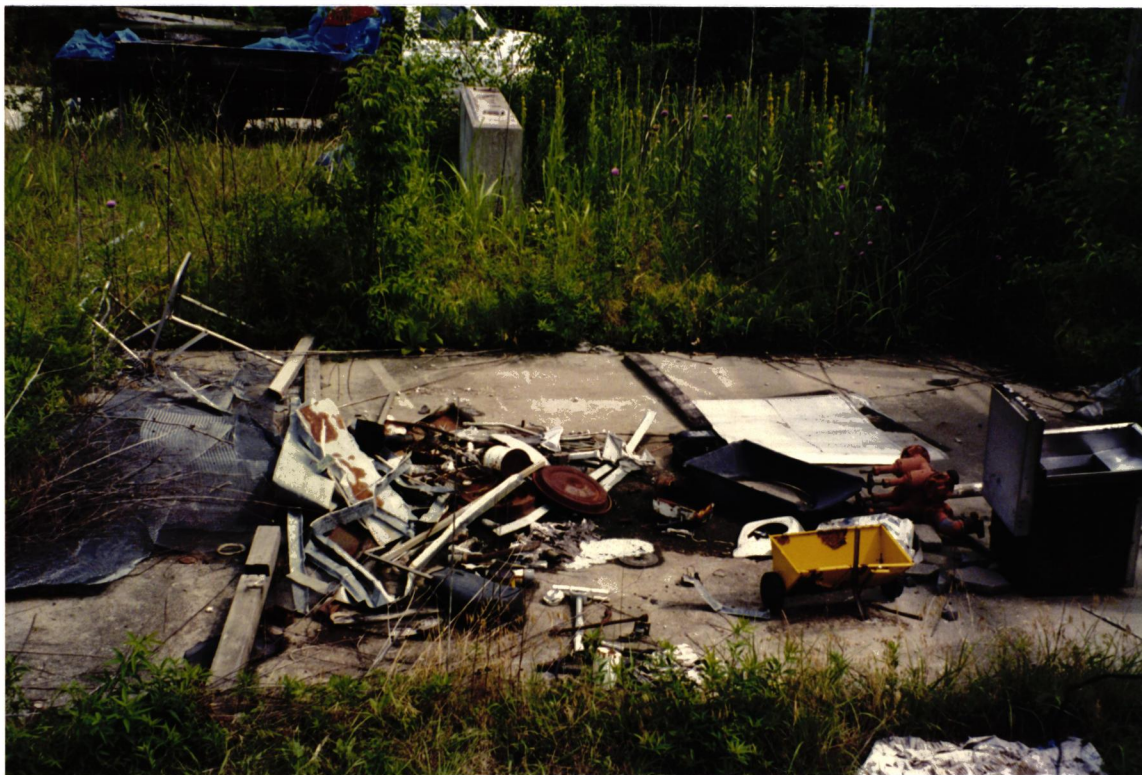
22

Facility: Thomas Hayward Agriculture & Nutrition
Location: Kansas City, KS **Photographer:** Jeffery Robichaud **Witness:** James Aycock **Date:** 6/27/95
Direction: North **Camera Type:** Fuji 35mm **Film Type:** 200 ASA **Time:** 1059
Subject: View of the concrete pad where a liquid nitrogen tank was formerly located. Note the miscellaneous scrap/salvage material located on the pad.

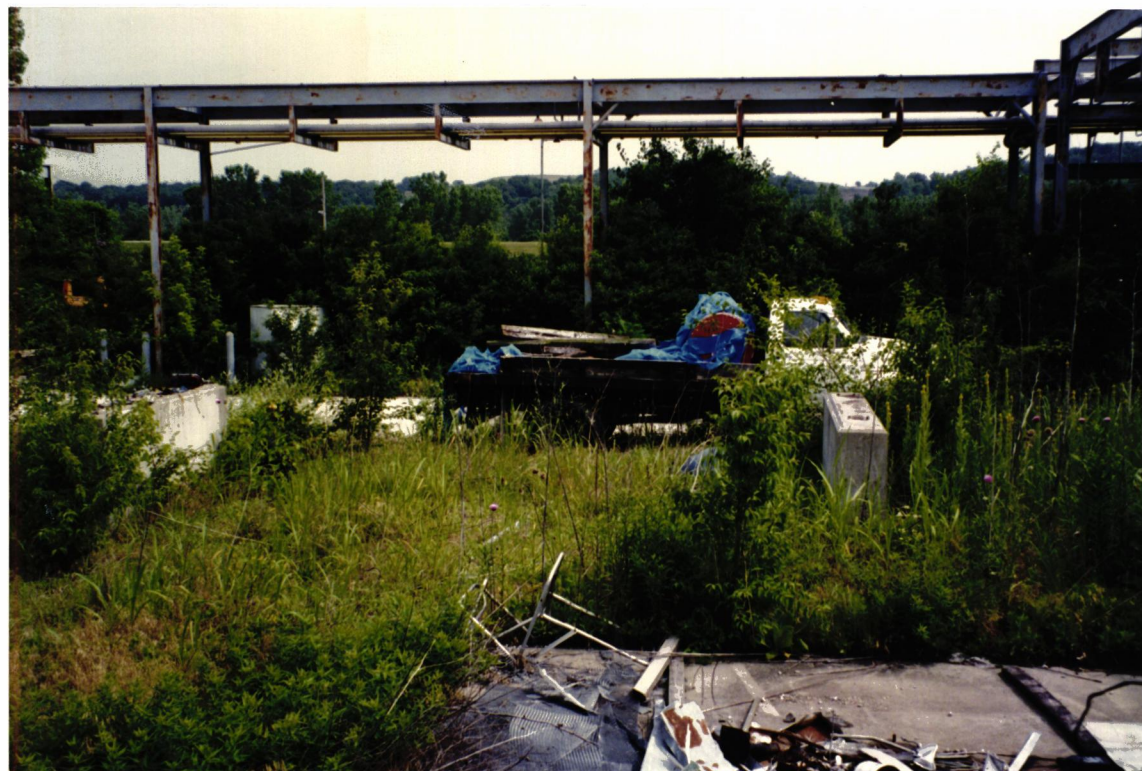
23

Facility: Thomas Hayward Agriculture & Nutrition
Location: Kansas City, KS **Photographer:** Jeffery Robichaud **Witness:** James Aycock **Date:** 6/27/95
Direction: North **Camera Type:** Fuji 35mm **Film Type:** 200 ASA **Time:** 1100
Subject: View of the concrete saddle where an LP gas tank was formerly located (One saddle is to the left in the photo, the other is to the right).

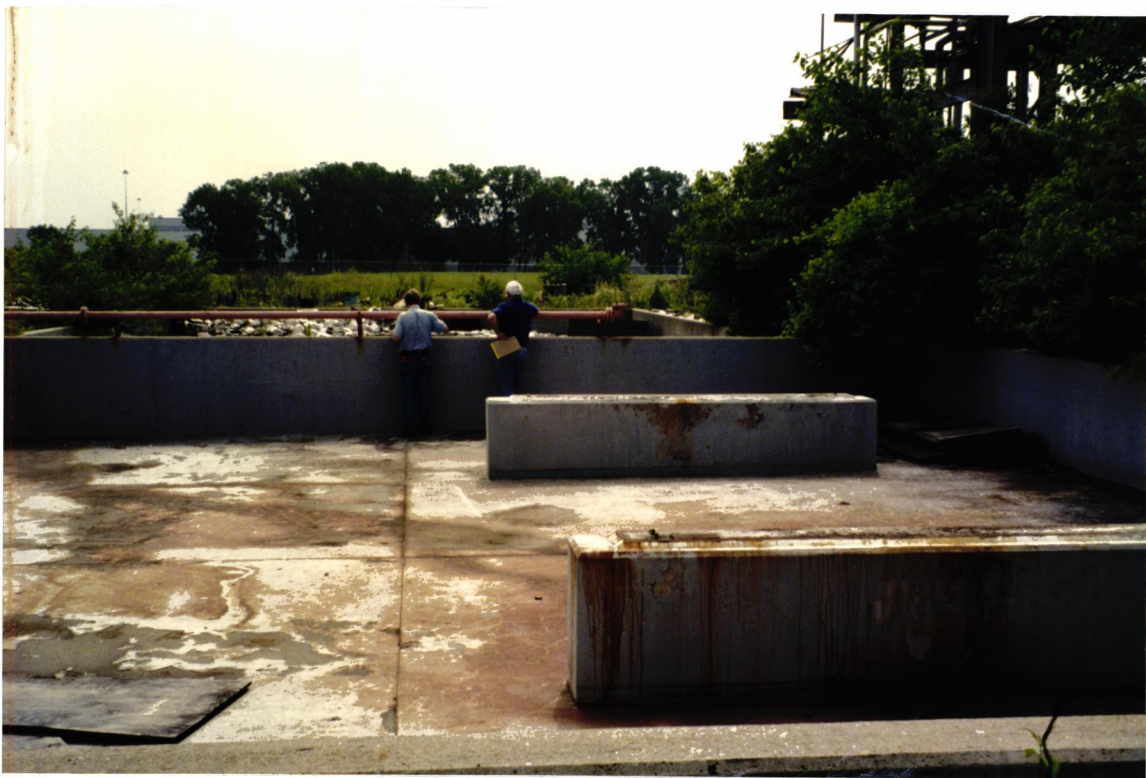
24

Facility: Thomas Hayward Agriculture & Nutrition
Location: Kansas City, KS **Photographer:** Jeffery Robichaud **Witness:** James Aycock **Date:** 6/27/95
Direction: East **Camera Type:** Fuji 35mm **Film Type:** 200 ASA **Time:** 1103
Subject: View of the concrete pad where an Hydrochloric Acid (HCl) tank was formerly stored (Foreground).

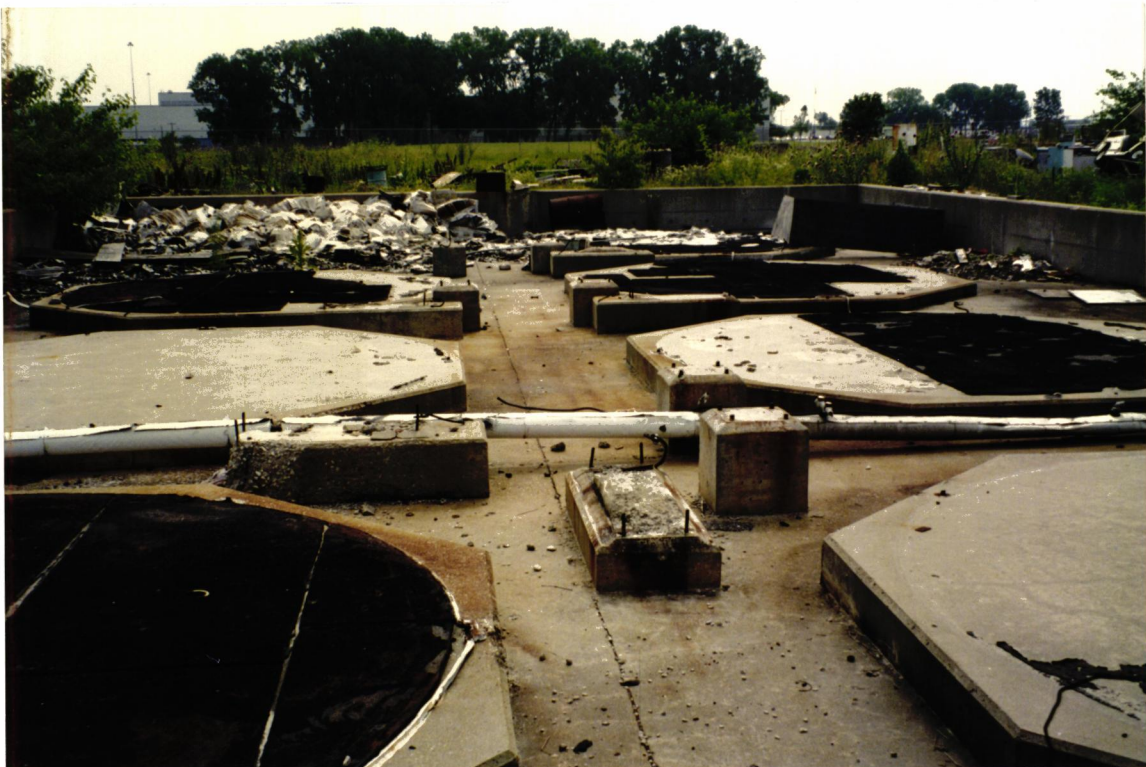
25

Facility: Thomas Hayward Agriculture & Nutrition
Location: Kansas City, KS **Photographer:** Jeffery Robichaud **Witness:** James Aycock **Date:** 6/27/95
Direction: East **Camera Type:** Fuji 35mm **Film Type:** 200 ASA **Time:** 1108
Subject: View of the concrete pad to the east of HCl pad. Formerly housed eight raw materials storage tanks.
Note the pile of paper and debris in the northeast corner of the pad.

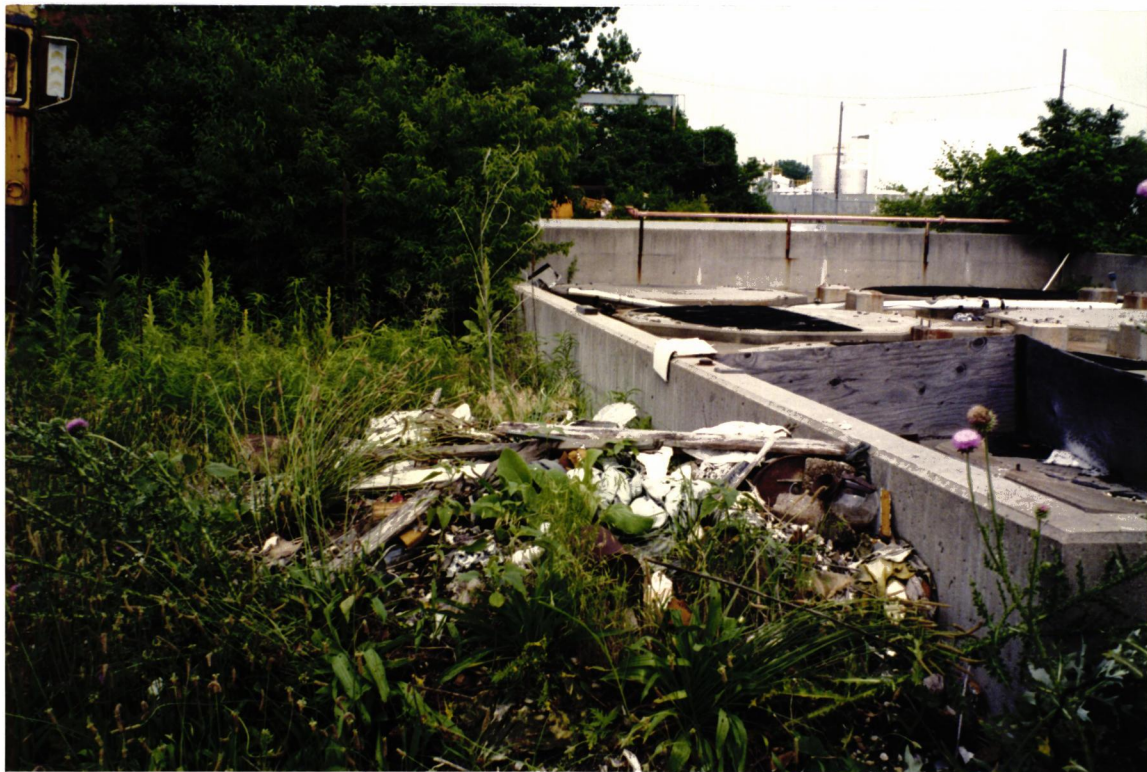
Subject: A pile of debris at the southeast corner of concrete pad which formerly housed eight raw materials storage tanks. Note the two corroded cans which may have contained solvent.

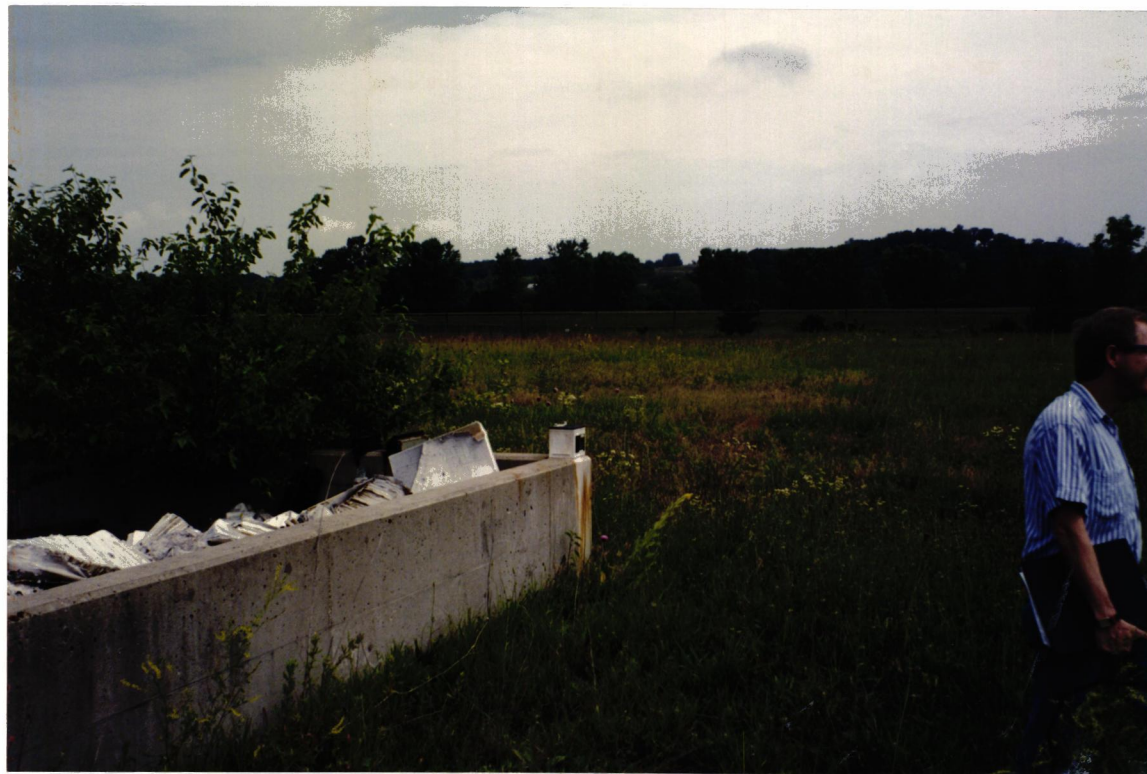
Subject: View of a battery on northeast corner of the containment wall which formerly housed the eight raw materials tanks. Notice the discoloration on the wall underneath the battery.

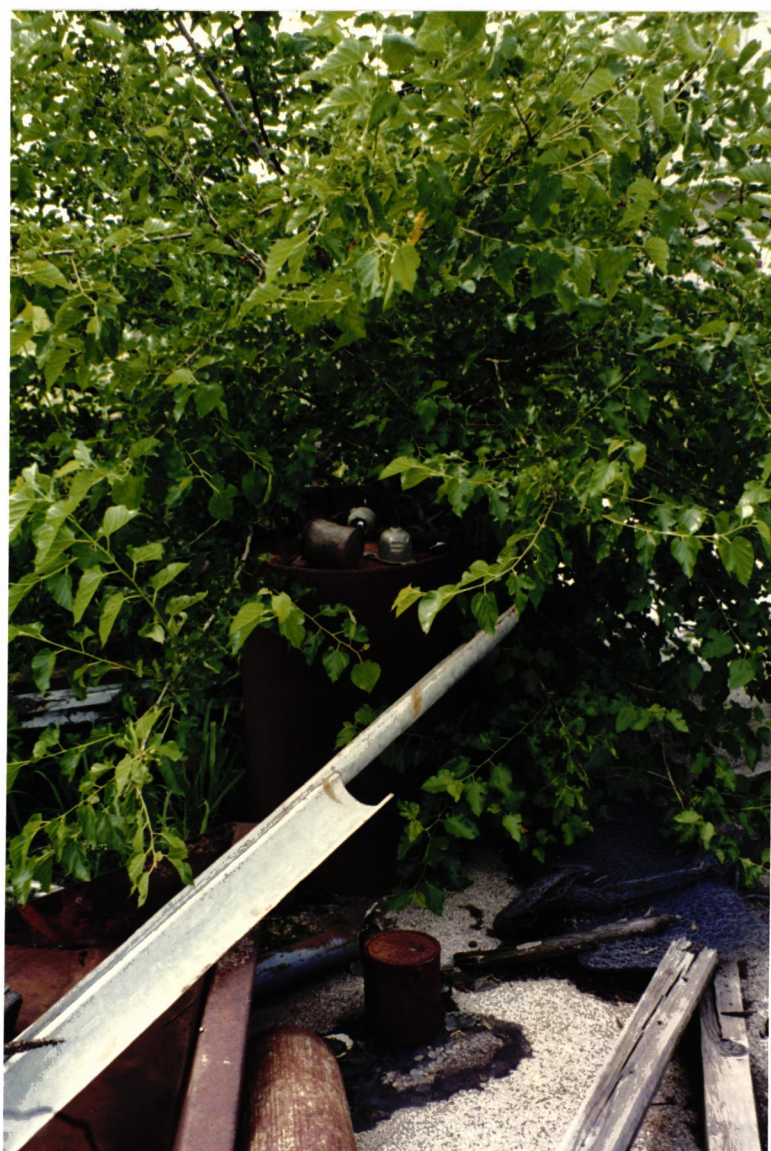
Subject: View of a corroded 55-gallon drum of unknown contents with a one-gallon paint can in front and several quart paint cans that contained orange and yellow paint on top. The one-gallon and quart cans were leaking.

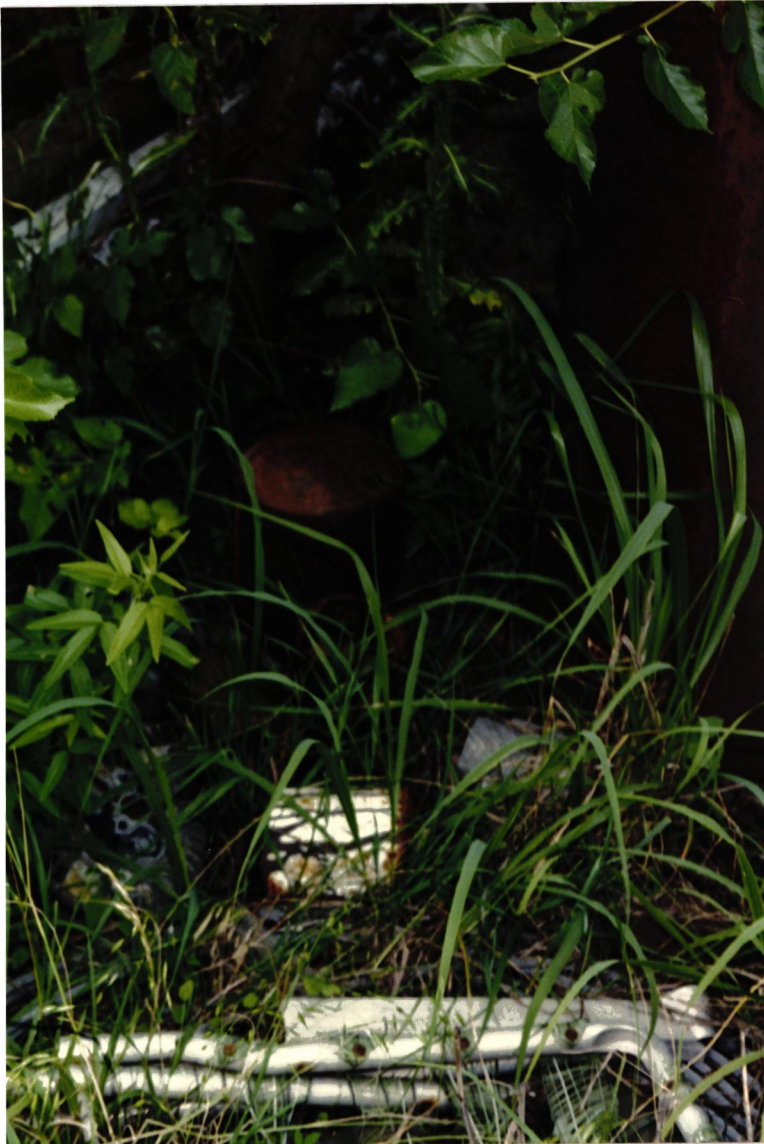
ROLL 2 PHOTO 29

Subject: A close-up of camouflage paint cans at the base of the 55-gallon drum, hidden in the foliage.

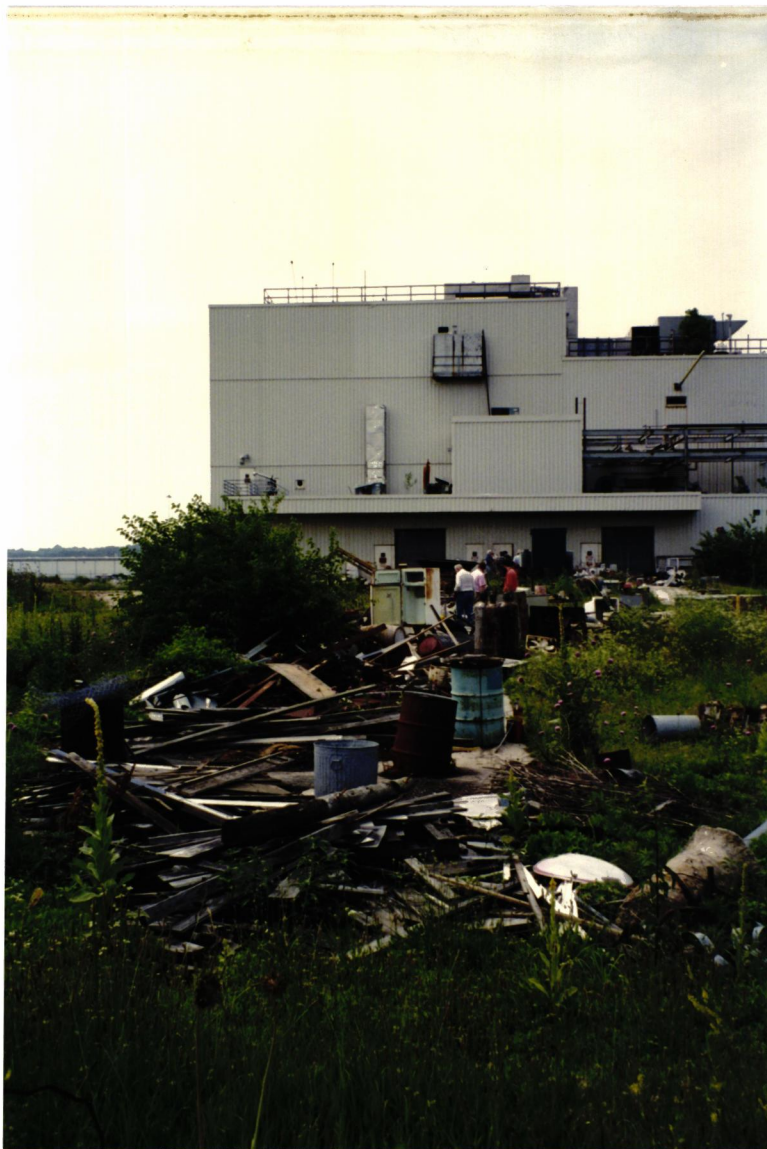
ROLL 2 PHOTO 30

Subject: View of the area north of the rear of the former DAITOM building. Note the six compressed gas tanks at the right center of the photo. All are labeled Thomas Hayward and have green tops. They appear to be empty.

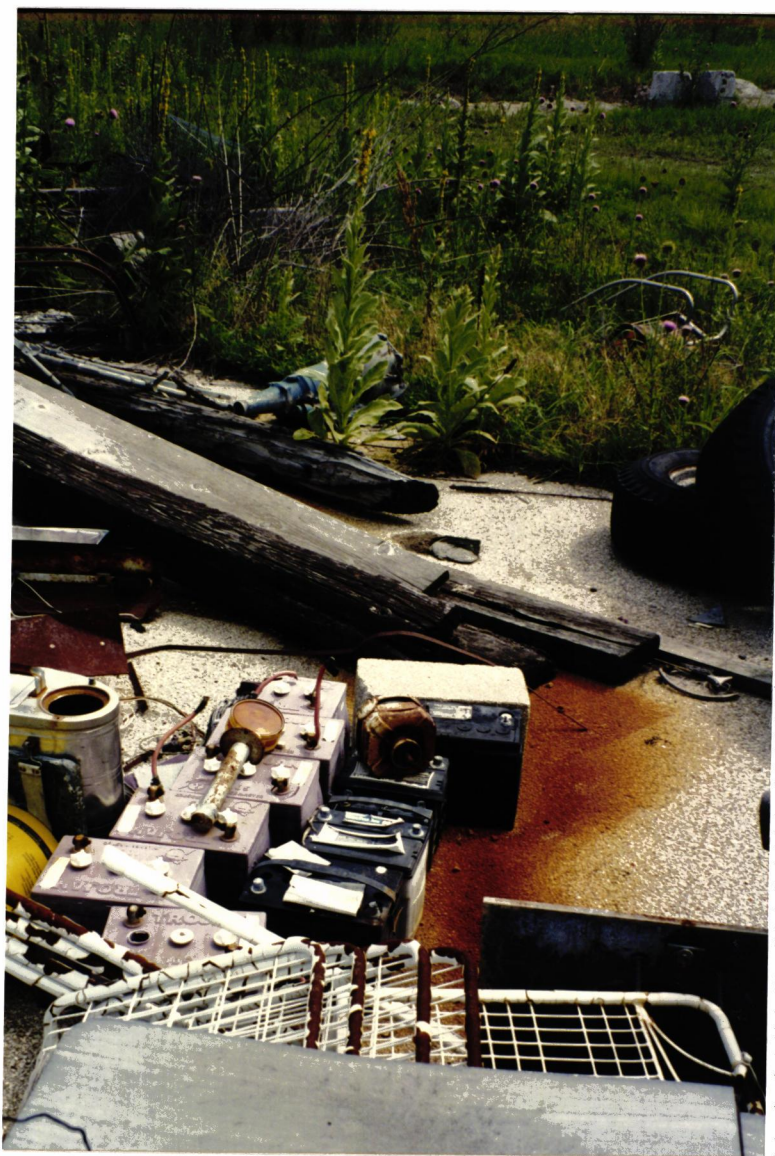
ROLL 2 PHOTO 31

Subject: A photo of a group of batteries on the paved area north of the rear of the former DAITOM plant. Note the trail of discoloration that leads away from the batteries and leaves the pad next to the blue object at the top of the photo entering the area with foliage.

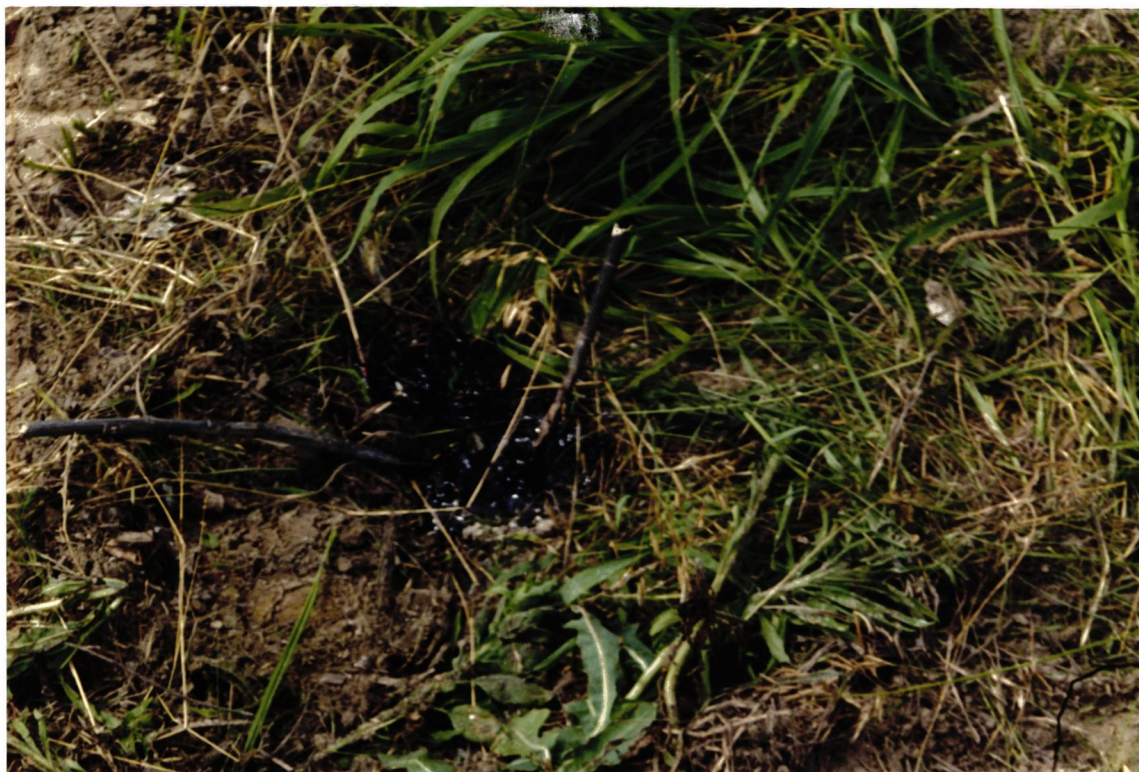
32

Facility: Thomas Hayward Agriculture & Nutrition
Location: Kansas City, KS **Photographer:** Jeffery Robichaud **Witness:** James Aycock **Date:** 6/27/95
Direction: N/A **Camera Type:** Fuji 35mm **Film Type:** 200 ASA **Time:** 1131
Subject: A photo of a dark liquid seep located in the soil four feet from the end of the asphalt road which runs in between the former laboratory/office building and the former boiler building.

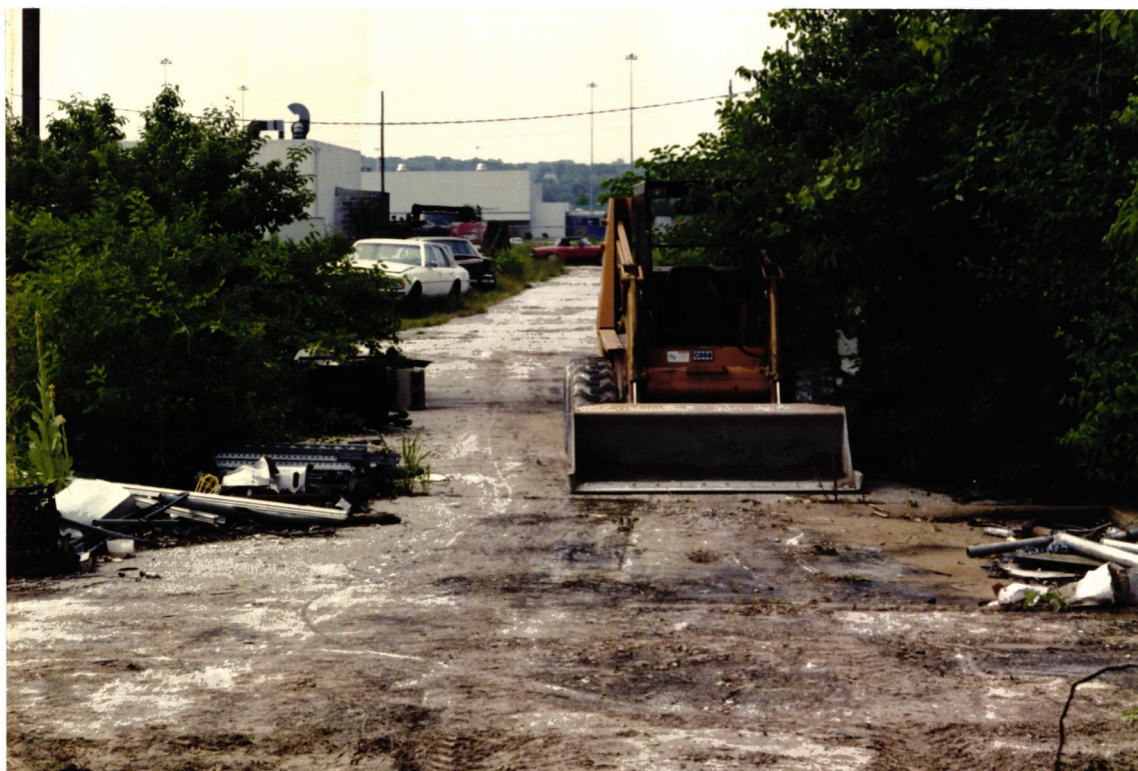
33

Facility: Thomas Hayward Agriculture & Nutrition
Location: Kansas City, KS **Photographer:** Jeffery Robichaud **Witness:** James Aycock **Date:** 6/27/95
Direction: South **Camera Type:** Fuji 35mm **Film Type:** 200 ASA **Time:** 1135
Subject: A photo of soil discoloration near the end of the asphalt road located between the former laboratory/office building and the former boiler building.

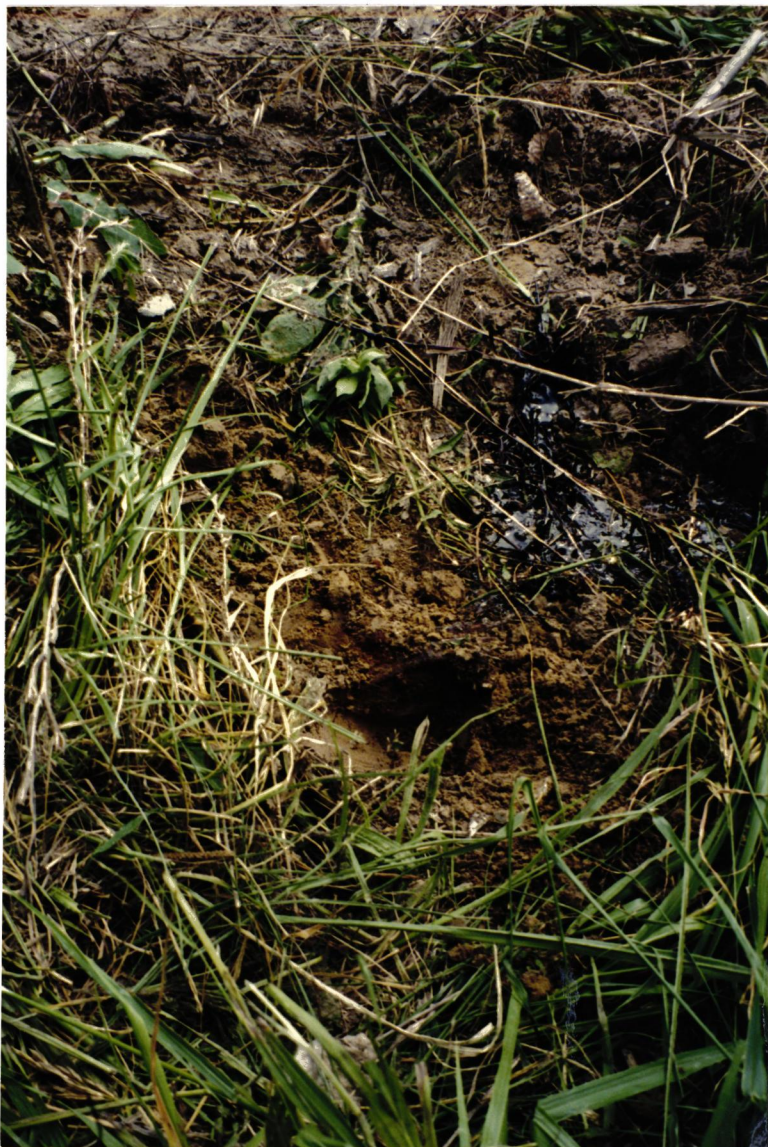
ROLL 2 PHOTO 34

Subject: A photo of the remnants of a metal container (in the center of the photo) located near the dark liquid seep. Size of the container is unknown.

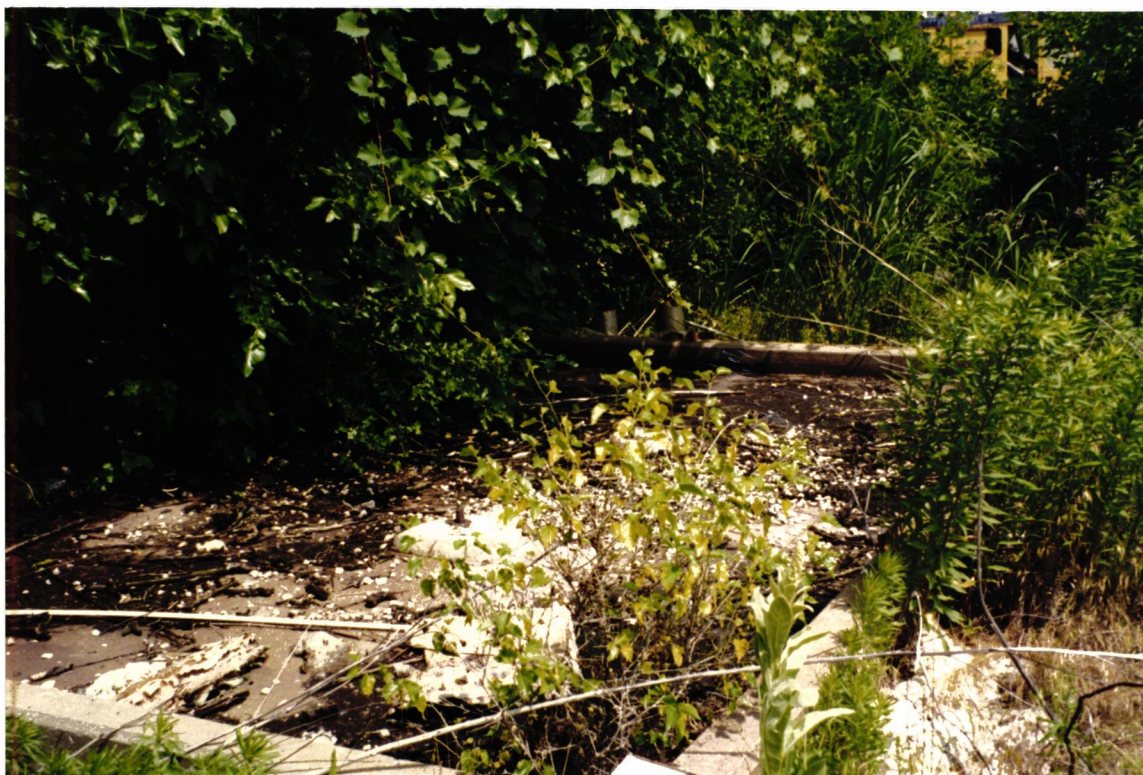
35

Facility: Thomas Hayward Agriculture & Nutrition
Location: Kansas City, KS **Photographer:** Jeffery Robichaud **Witness:** James Aycock **Date:** 6/27/95
Direction: North **Camera Type:** Fuji 35mm **Film Type:** 200 ASA **Time:** 1140
Subject: View of the concrete pad where an ethyl acetate tank was formerly located.

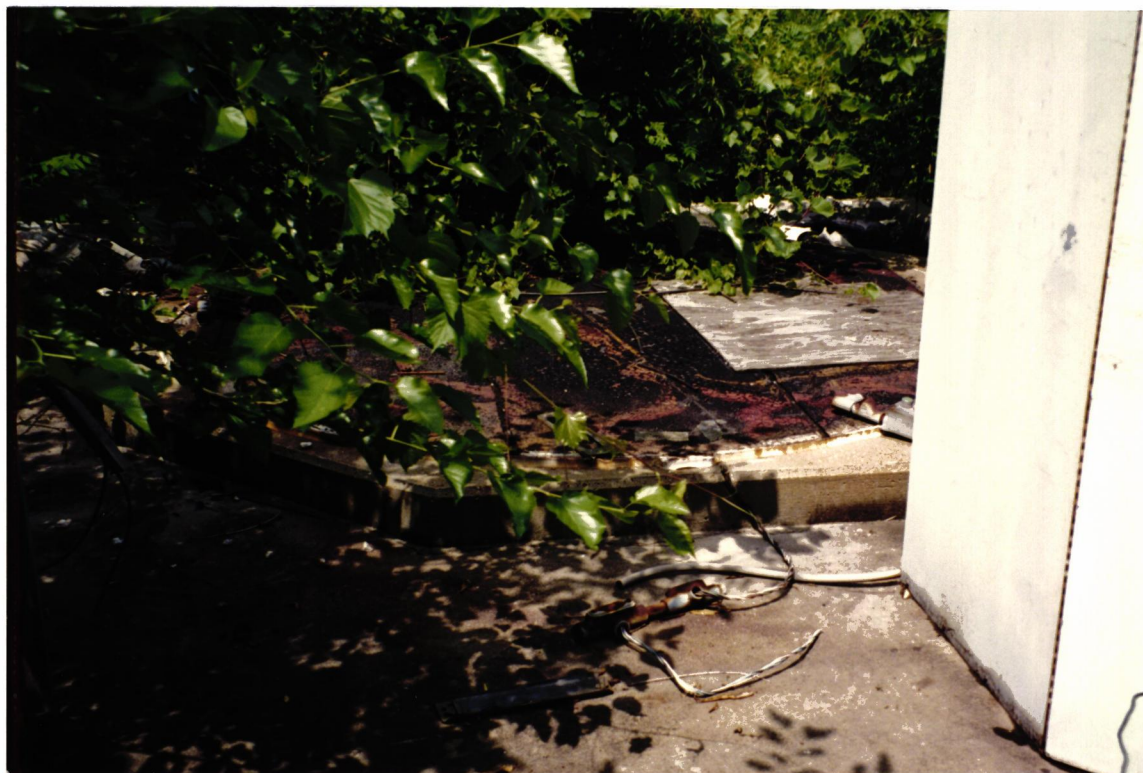
36

Facility: Thomas Hayward Agriculture & Nutrition
Location: Kansas City, KS **Photographer:** Jeffery Robichaud **Witness:** James Aycock **Date:** 6/27/95
Direction: South **Camera Type:** Fuji 35mm **Film Type:** 200 ASA **Time:** 1151
Subject: View of the concrete pad where a methanol tank was formerly stored.

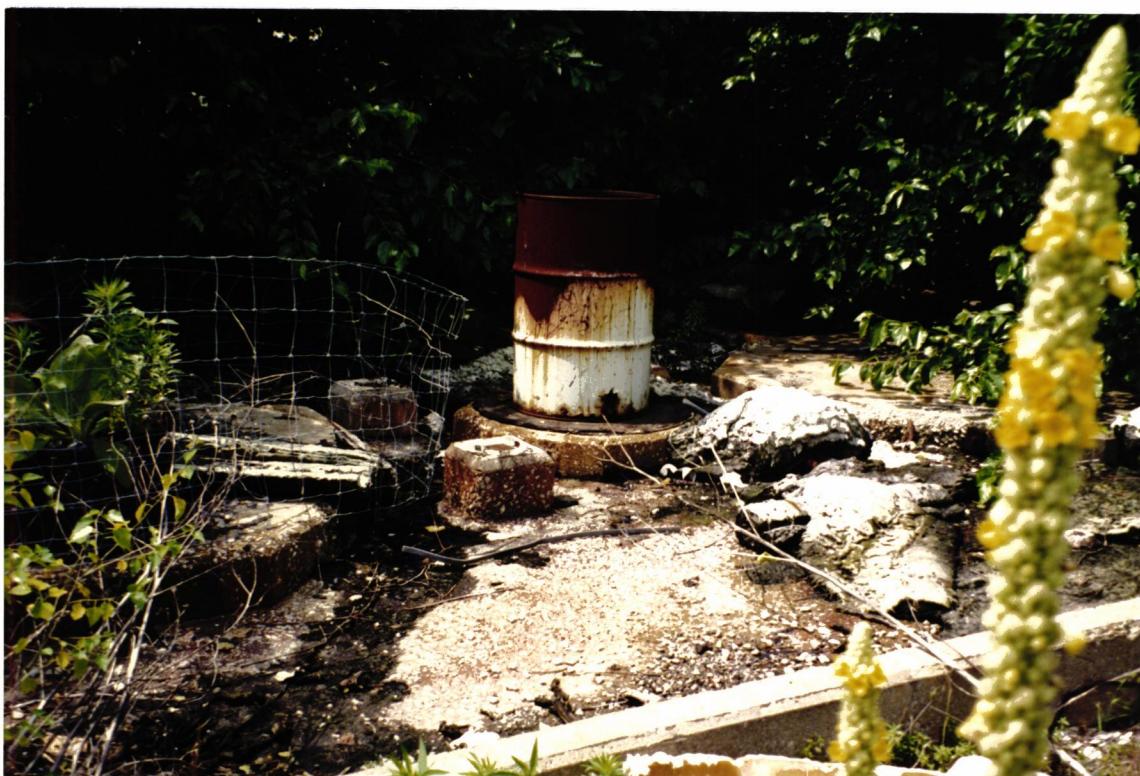
37

Subject: View of the pad where a cyanide destruction unit was formerly located.

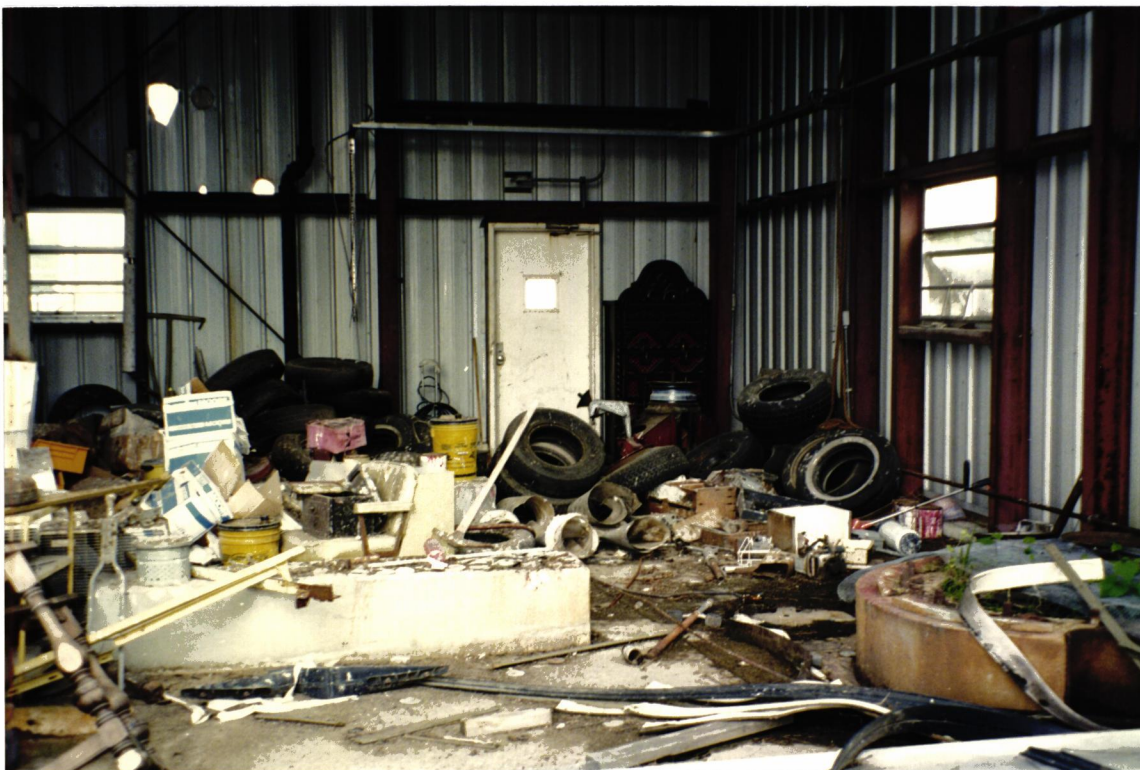
1

Subject: View of the inside of the northeast corner of the former boiler building. Note the miscellaneous scrap/salvage material.

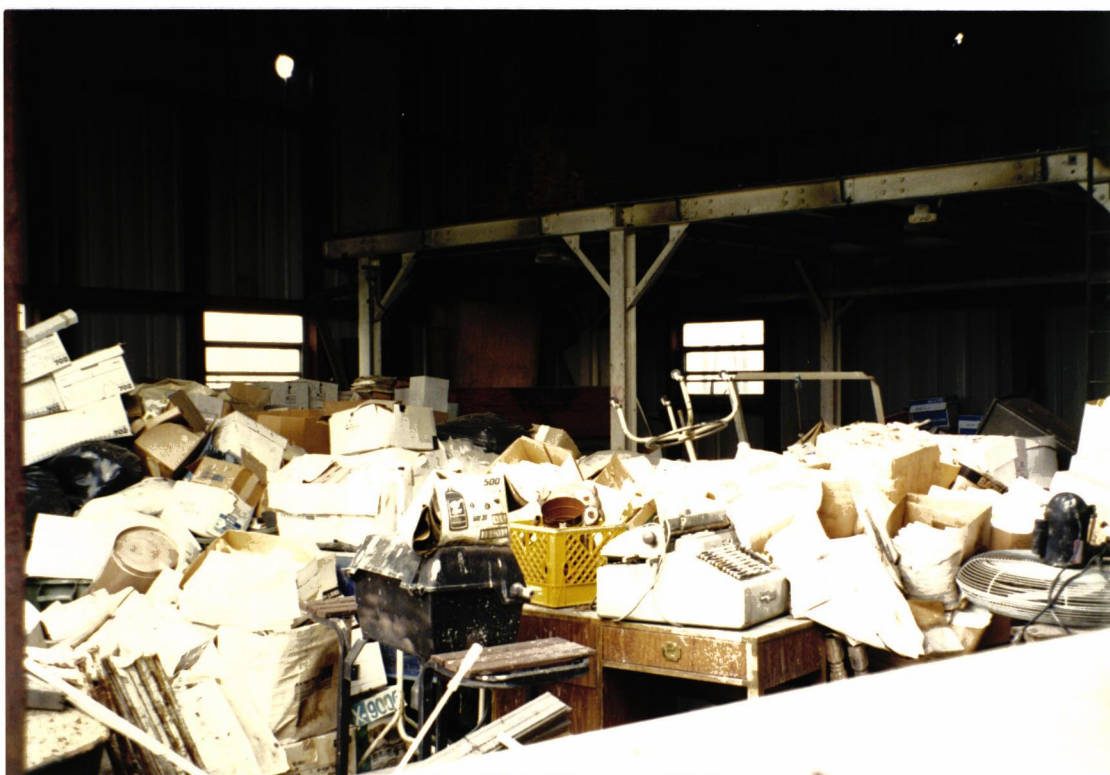
2

Facility: Thomas Hayward Agriculture & Nutrition
Location: Kansas City, KS **Photographer:** Jeffery Robichaud **Witness:** James Aycock **Date:** 6/27/95
Direction: Northwest **Camera Type:** Fuji 35mm **Film Type:** 200 ASA **Time:** 1321
Subject: View of the inside of the northwest corner of the former boiler building. Note the miscellaneous scrap/salvage material.

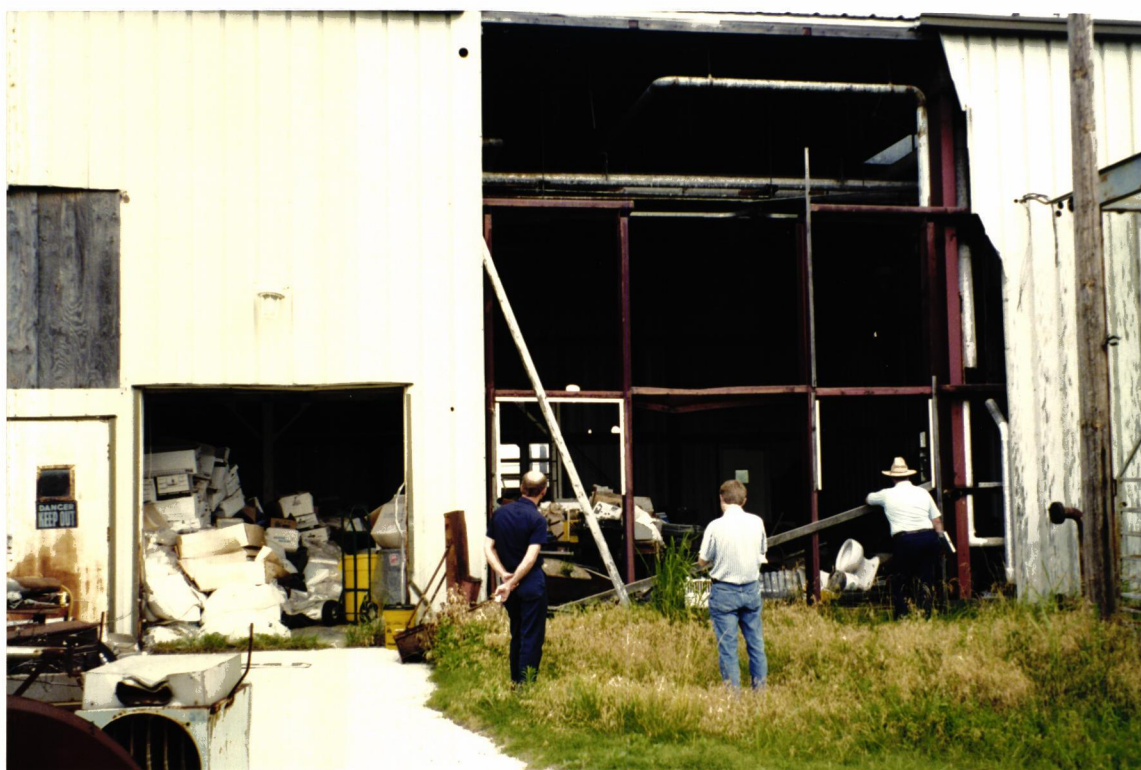
3

Facility: Thomas Hayward Agriculture & Nutrition
Location: Kansas City, KS **Photographer:** Jeffery Robichaud **Witness:** James Aycock **Date:** 6/27/95
Direction: North **Camera Type:** Fuji 35mm **Film Type:** 200 ASA **Time:** 1321
Subject: View of the south side of the former boiler building.

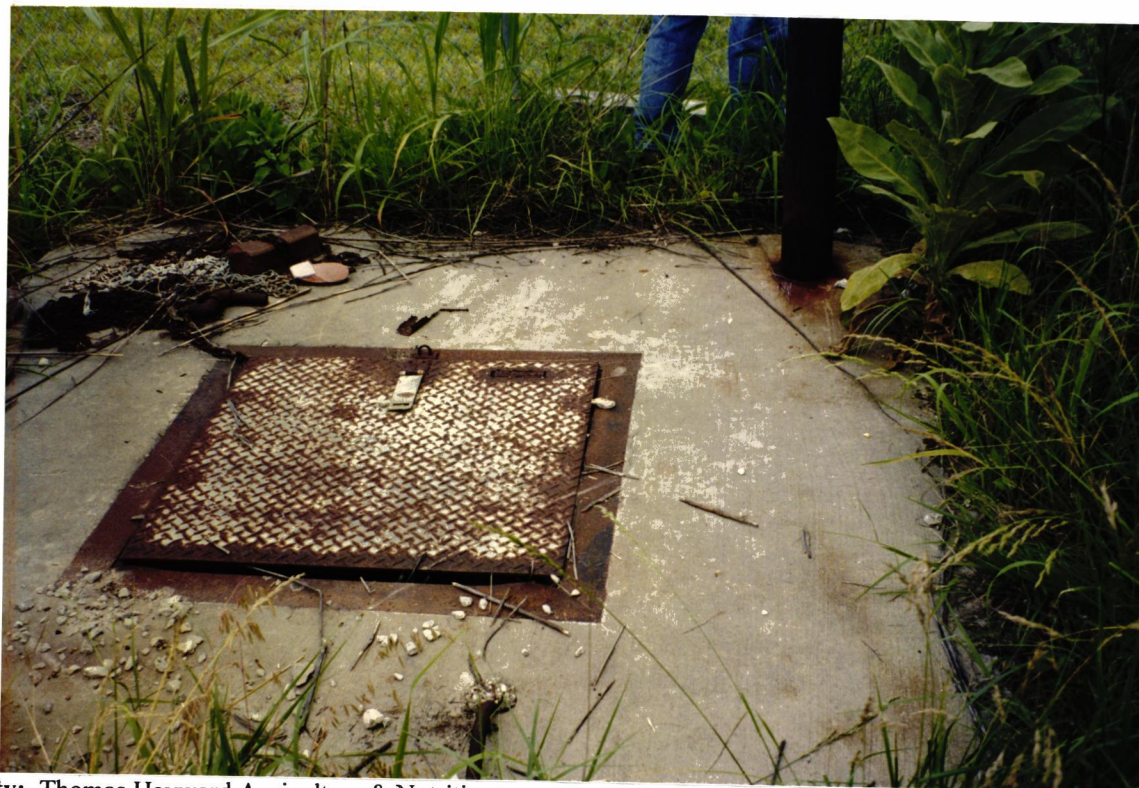
Subject: Lift station located to the north of the former boiler building

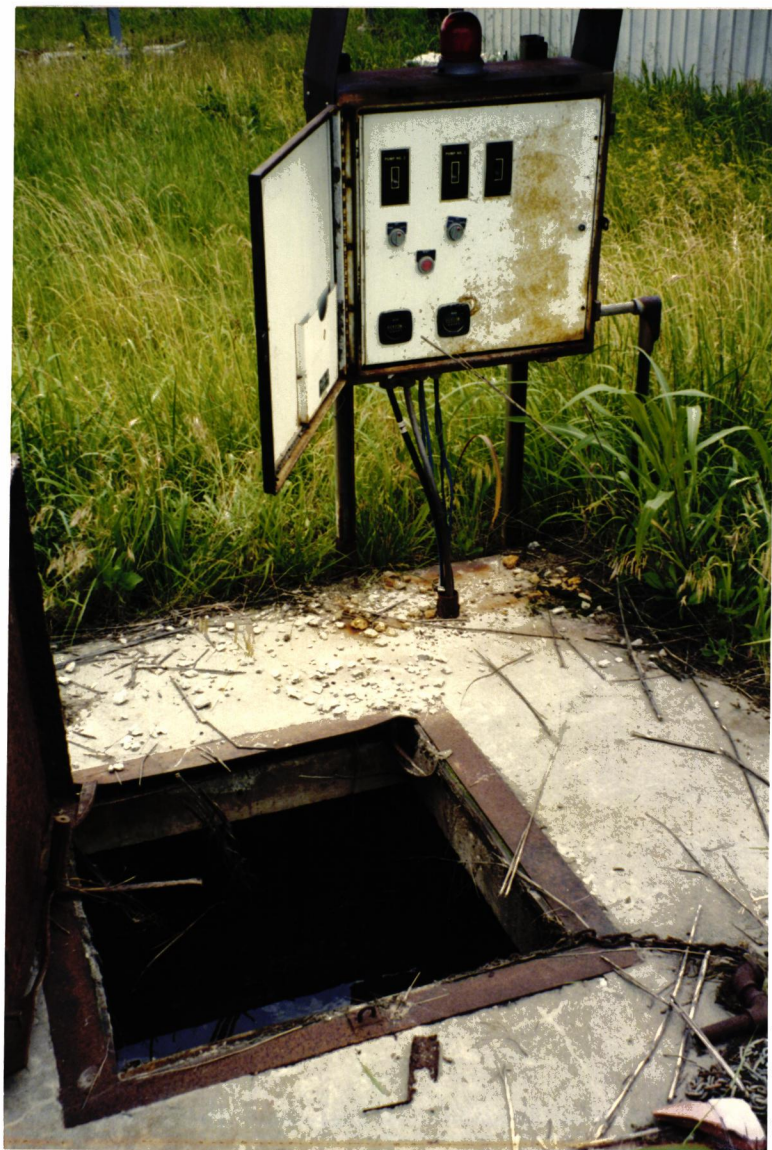
ROLL 3 PHOTO 5

Subject: Lift Station and pump control panel located to the north of the former boiler building.

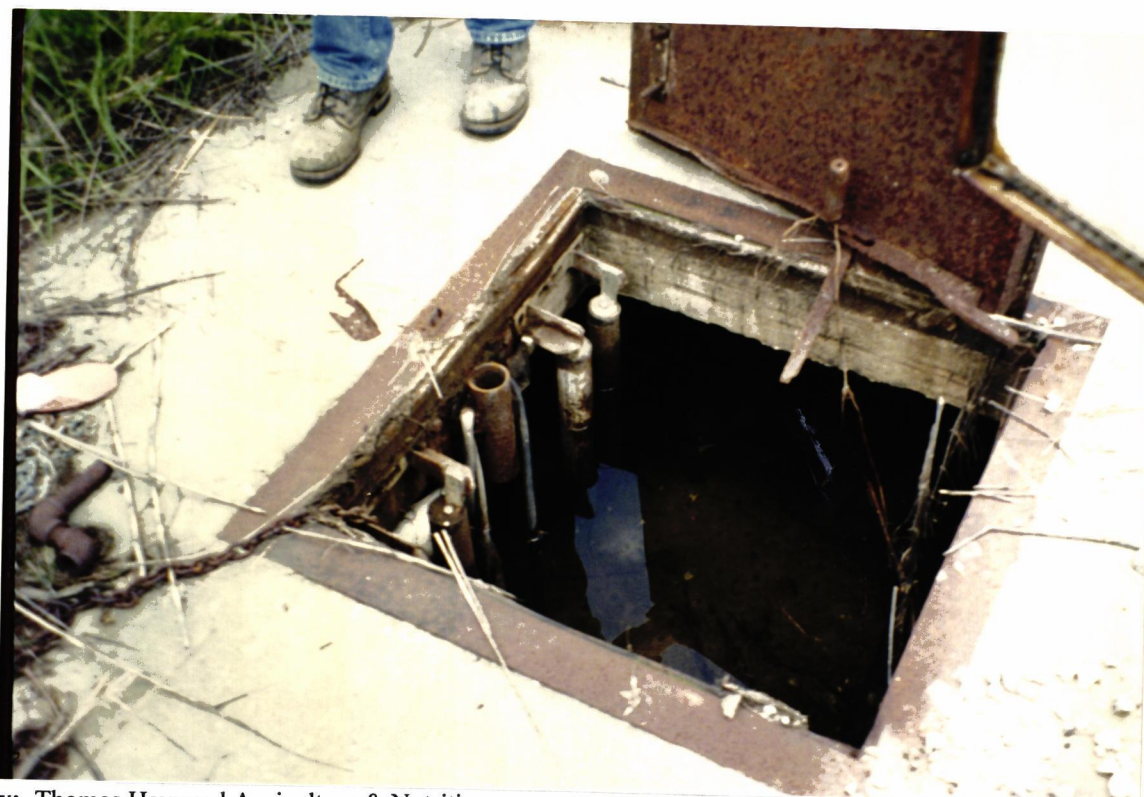
6

Subject: View of the inside portion of the lift station.

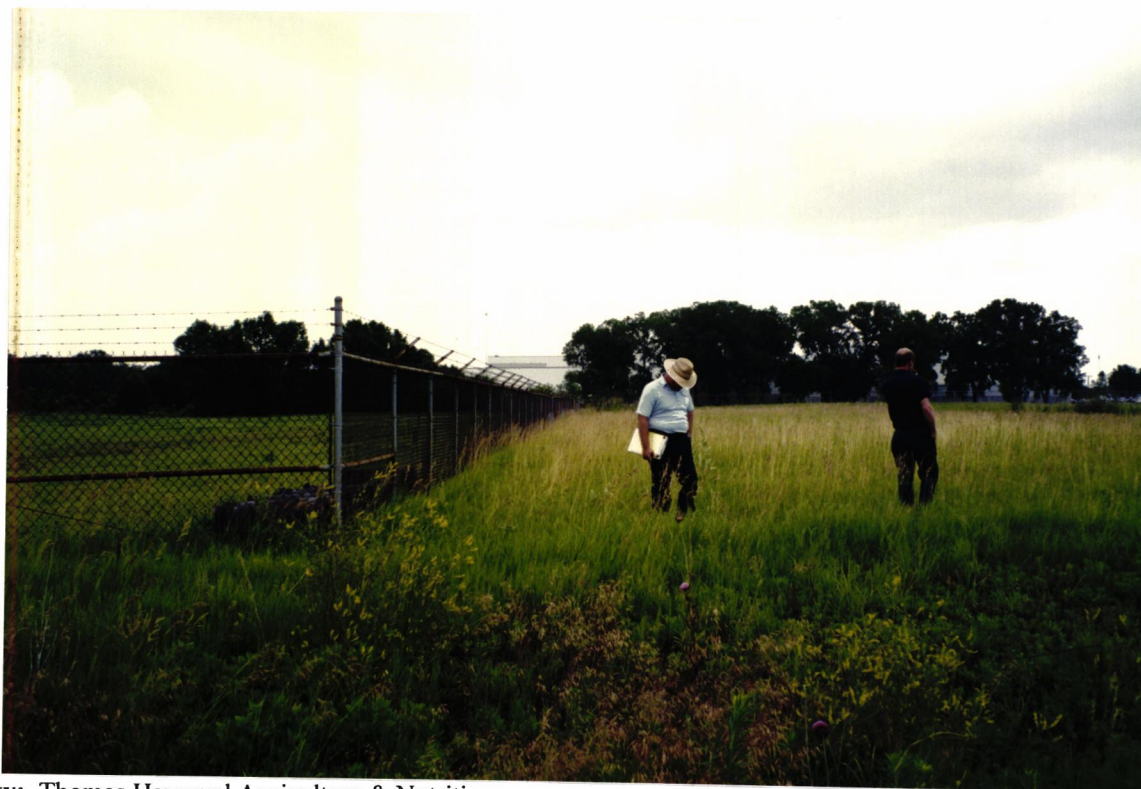
7

Subject: The former THAN surface impoundment (left side of the photo) is behind the fence. Note drums in the southwest corner. They appeared to be empty, however several of the drums had burst open and may have released their contents to the soil.

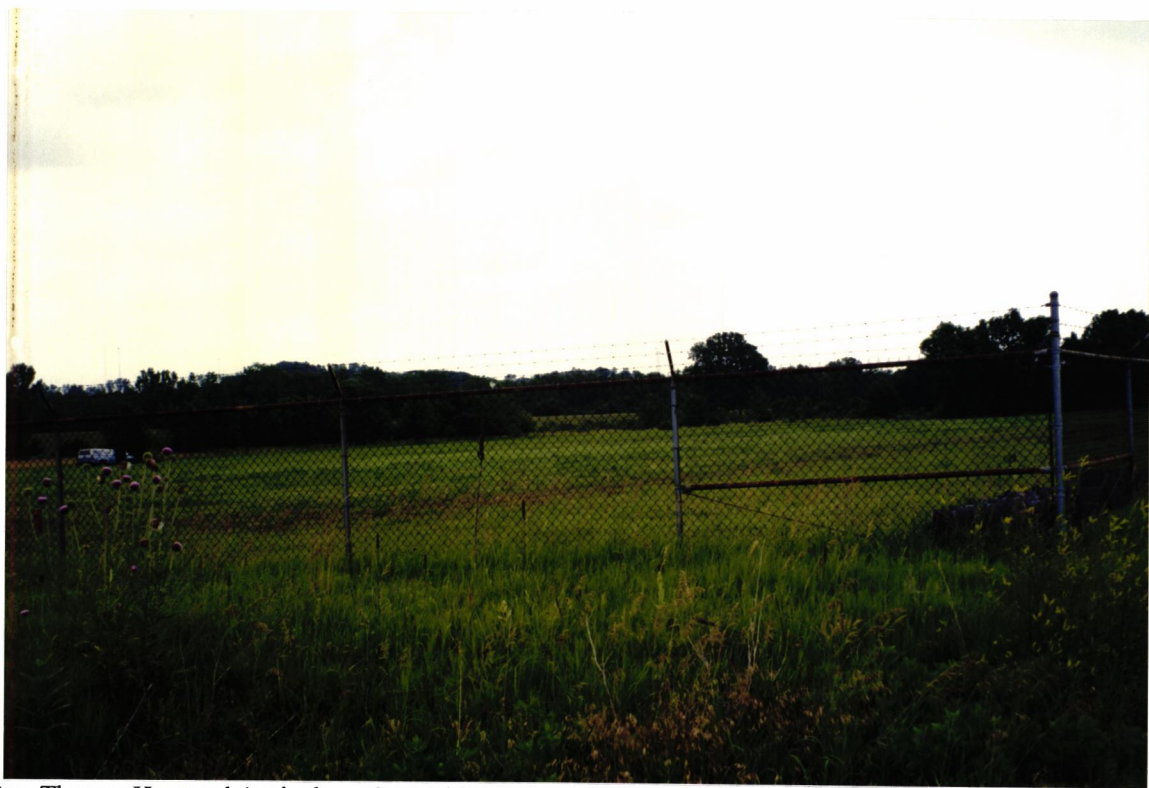
8

Subject: View of the former THAN surface impoundment (the area behind the fence).
